TEST REPORT

REPORT No.:
CTK-2019-01685-2
Page (1) / (11) pages

4. Test Sample / Model: NETWORK CAMERA / QNE-8021R

1. Degrees of protection provided by enclosures for electrical equipment against external mechanical impacts (IK code)

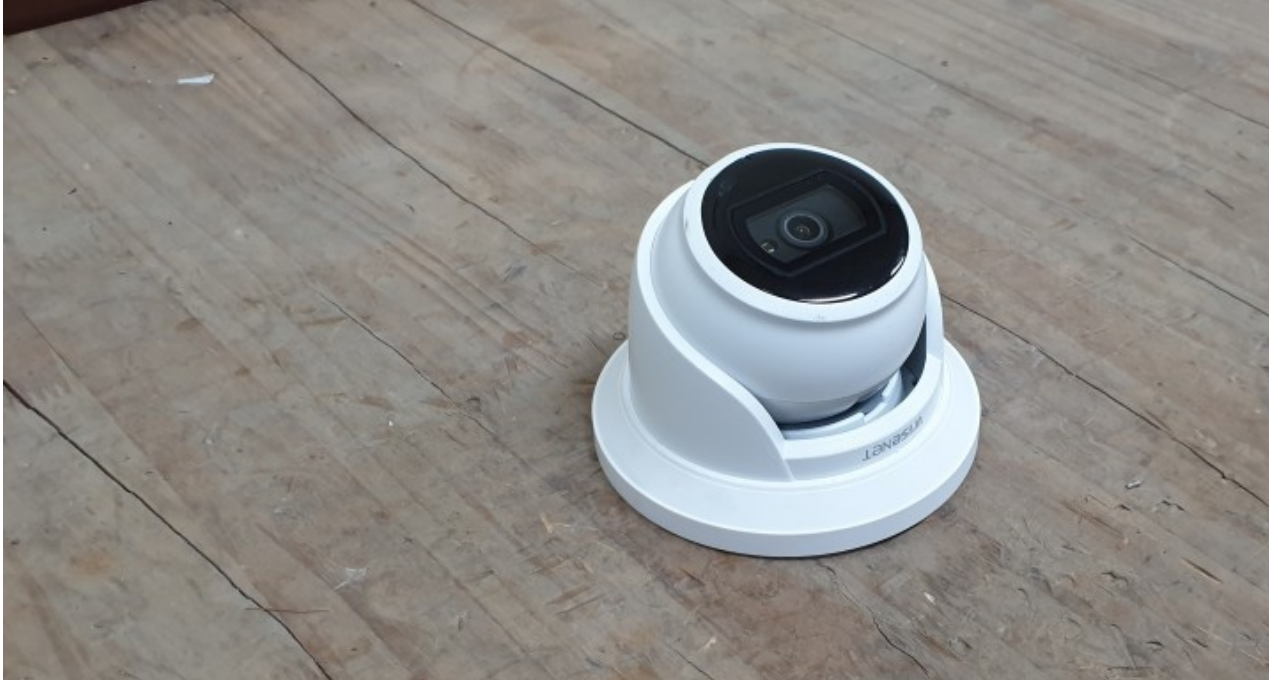
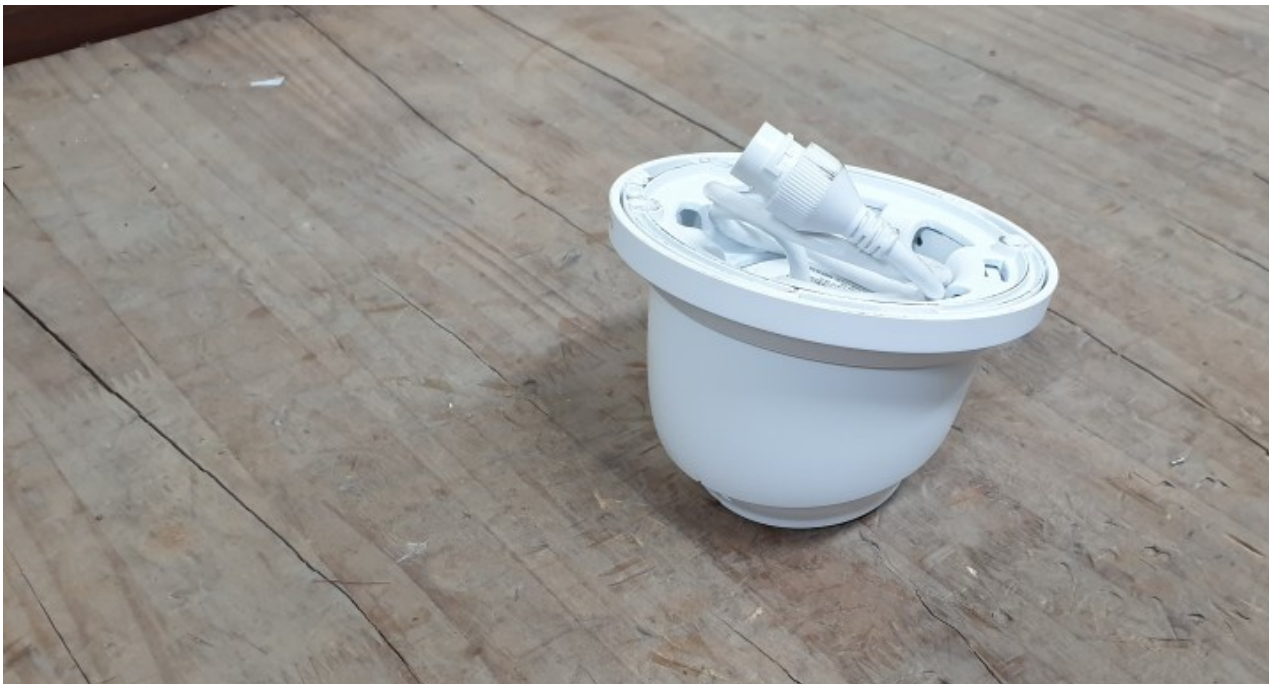
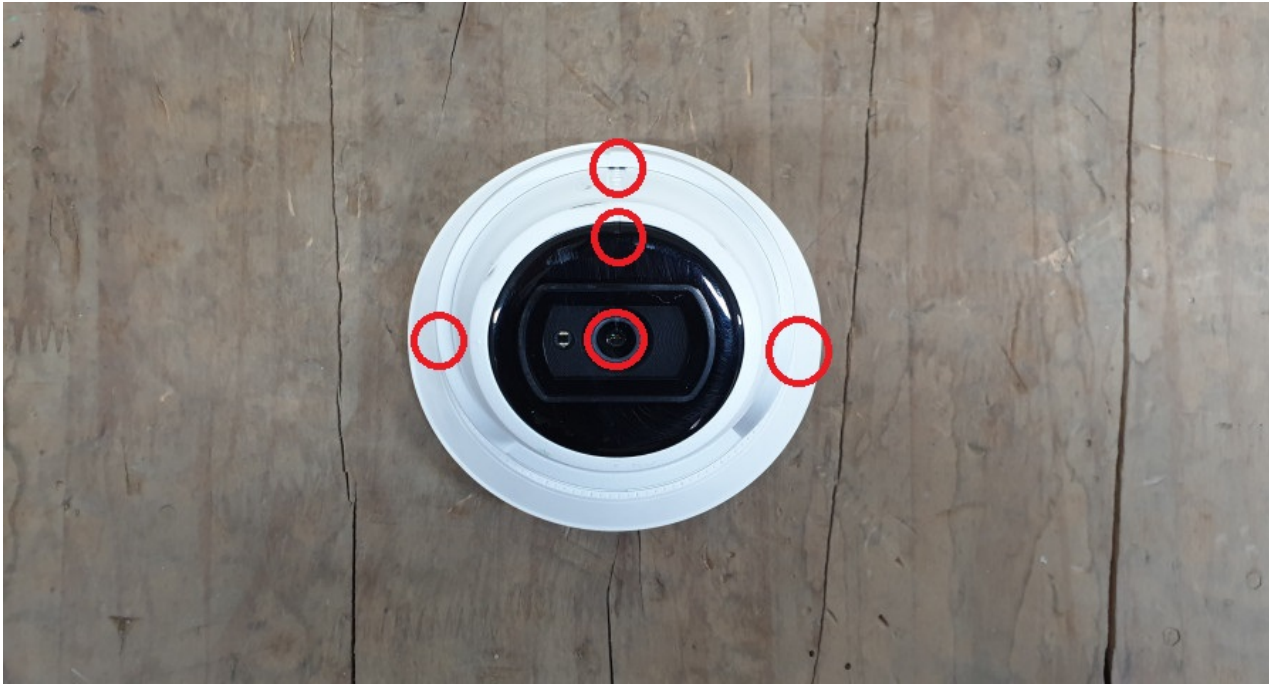
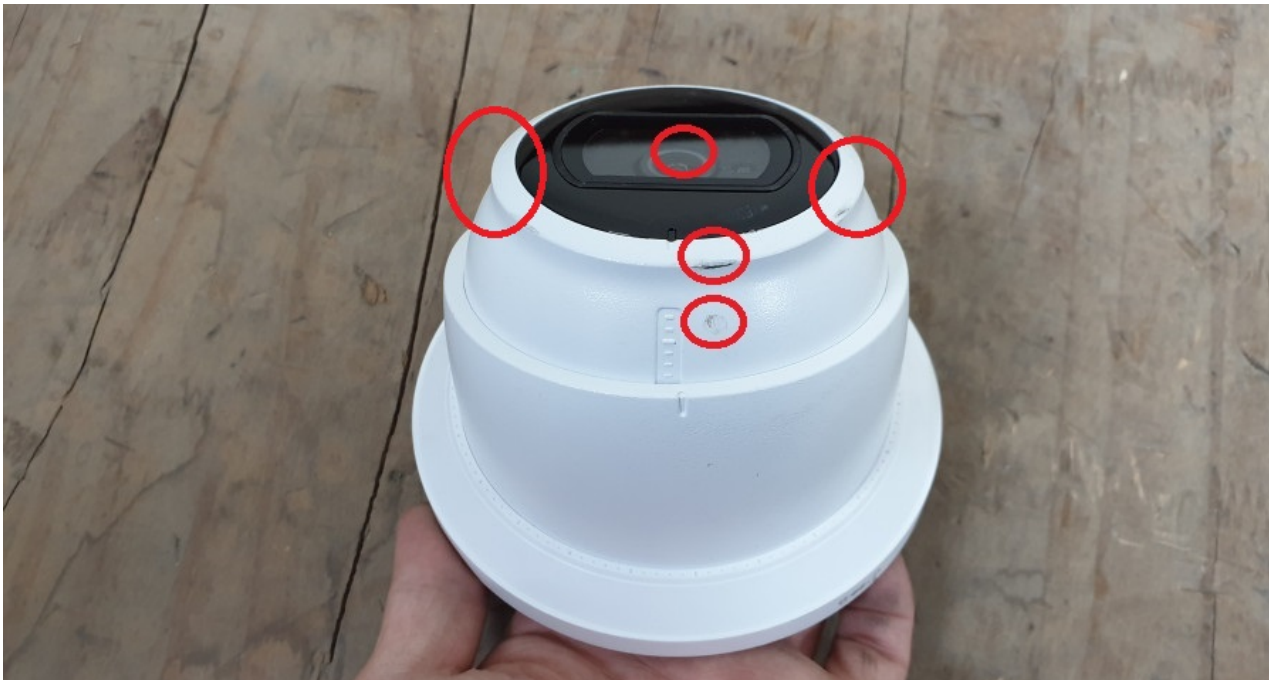
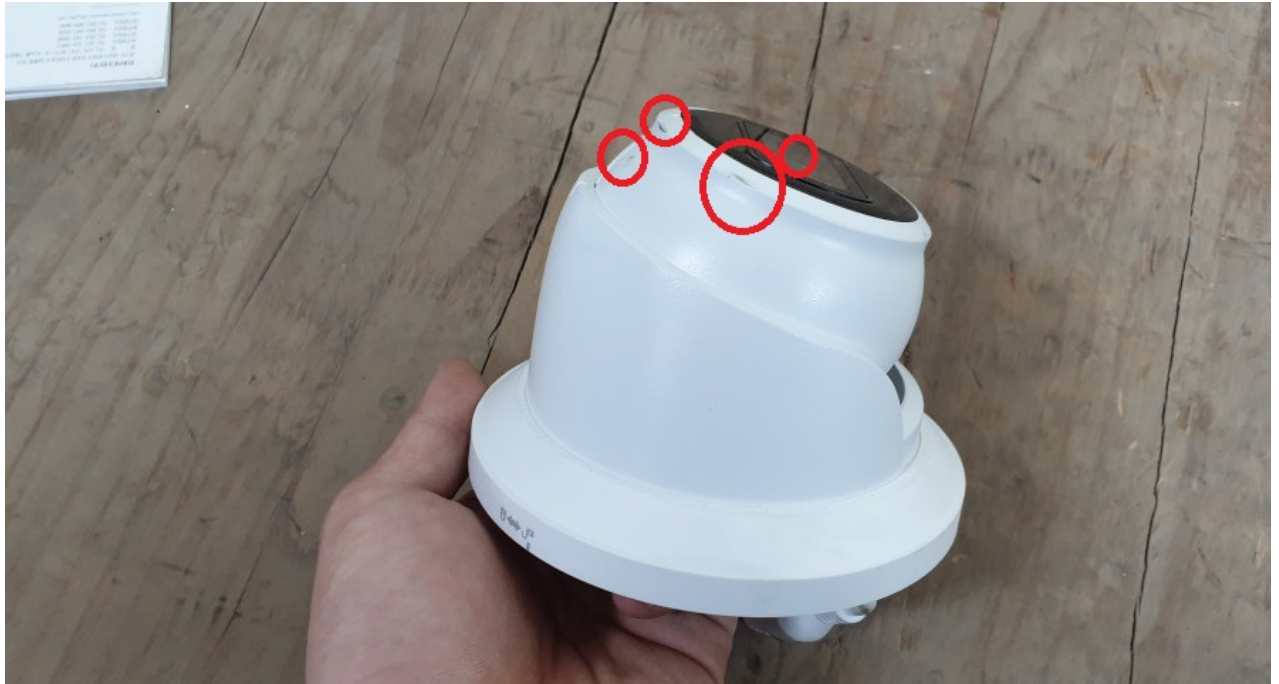
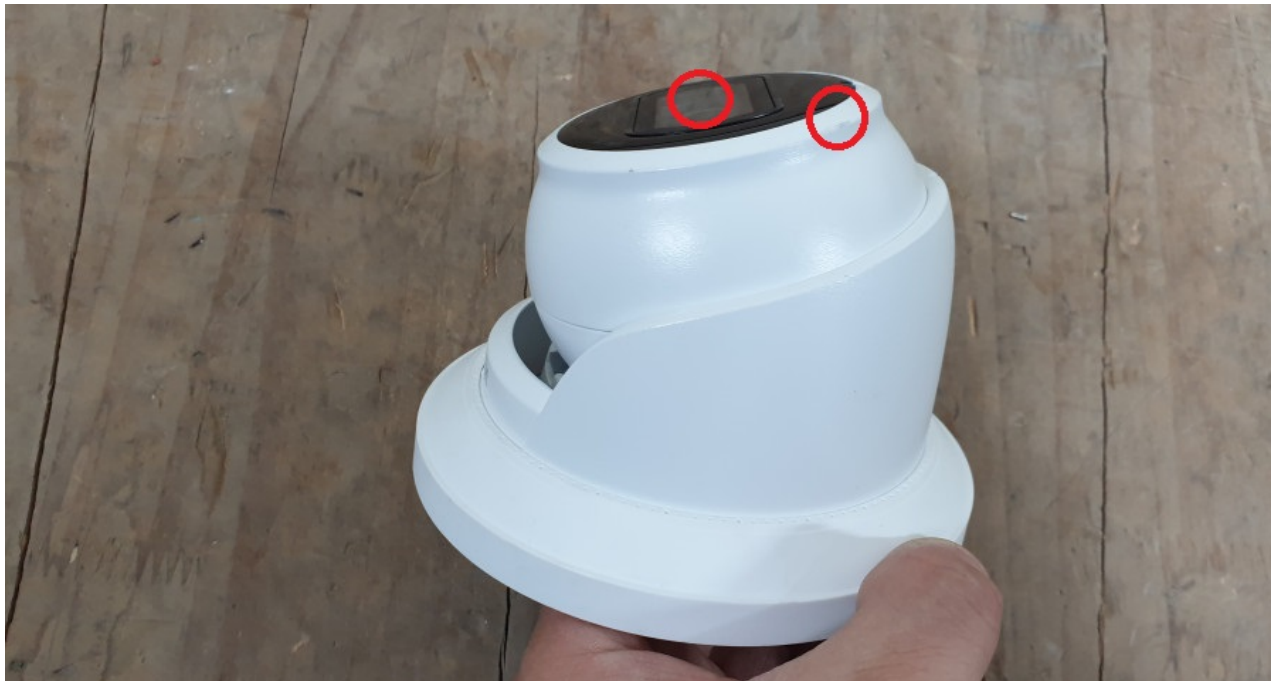
2.3 Photos after test

Item	Contents	Result
External protection Enclosure	No damage	Pass
Comment Some scratches were generated on the outside of the product.
